Fractographic Inspection of the
Cracking FT488/2 Removed at
Program 79

DSTO-TN-0170

**Airframes and Engines Division
Aeronautical and Maritime Research Laboratory**

During the inspection of the FT488/2 Bare Bulkhead Fatigue Test specimen after 79 blocks of applied loading, cracking was found in several wing-attachment hole aft edges. Each of the cracked regions of the holes was cut from the bulkhead, sixteen of the cracks were broken open and the exposed crack surfaces were analysed. This analysis revealed several interesting aspects of fatigue crack growth in this bulkhead. These included the nature of the most (in this case) significant initiating flaws, the type (compared to other thick 7050 plate material) and effect of the microstructure on the growth of these cracks, and the relative growth rates of these cracks including estimates of the number of programs to failure.

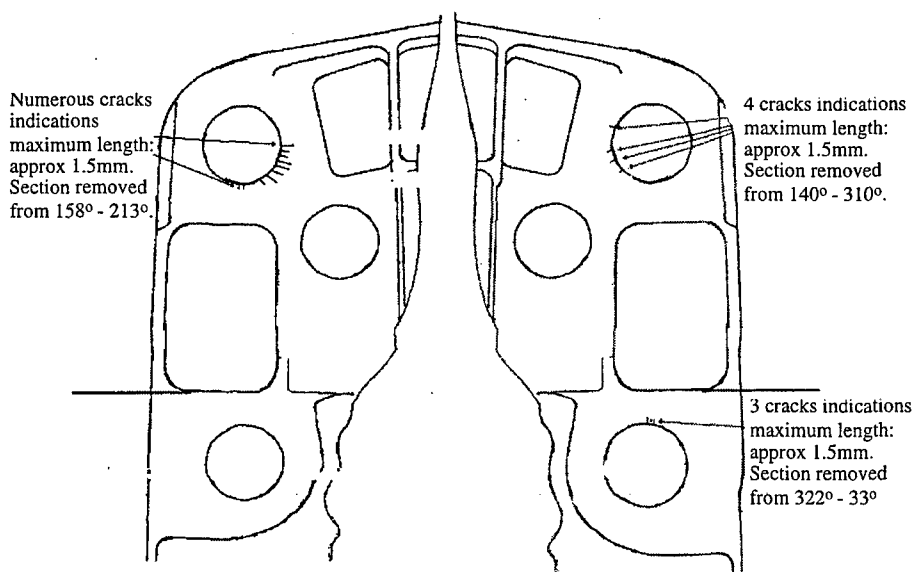
Figure 1. The position of the cracking found in the wing-attachment hole aft edges. Also, note the extent of the region removed is marked.

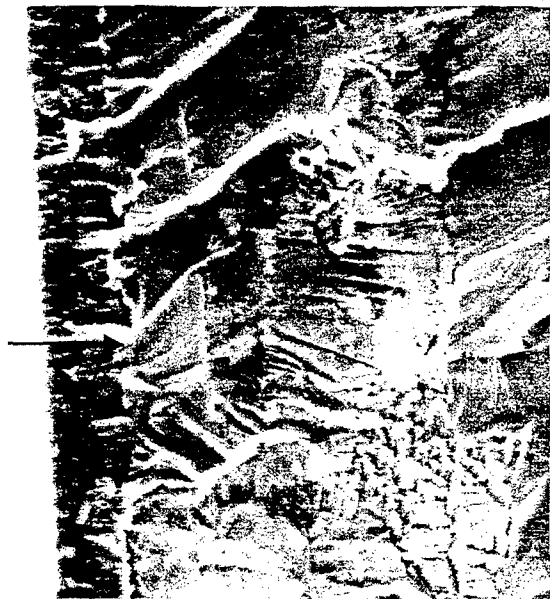
2.3.10 Port upper aft edge – Crack 2

This crack originated from multiple sites beneath the intact IVD coating on the aft face of the bulkhead. These sites were spread over about a 0.5mm length centred about 0.5mm from the hole edge. The numerous cracks joined to form a single crack front, Figure 21A. Small etch-pits, probably associated with grain boundaries, acted as the initiating flaws. Intersection with the wing-attachment hole probably occurred relatively late in the crack growth life - at a crack depth of about 200µm.

Figure 21. The line shown in view A designates the approximate line followed during fractography. The cracking initiated beneath the IVD at the surface of the 7050. The initiation site used in the fractography is marked with an arrow.

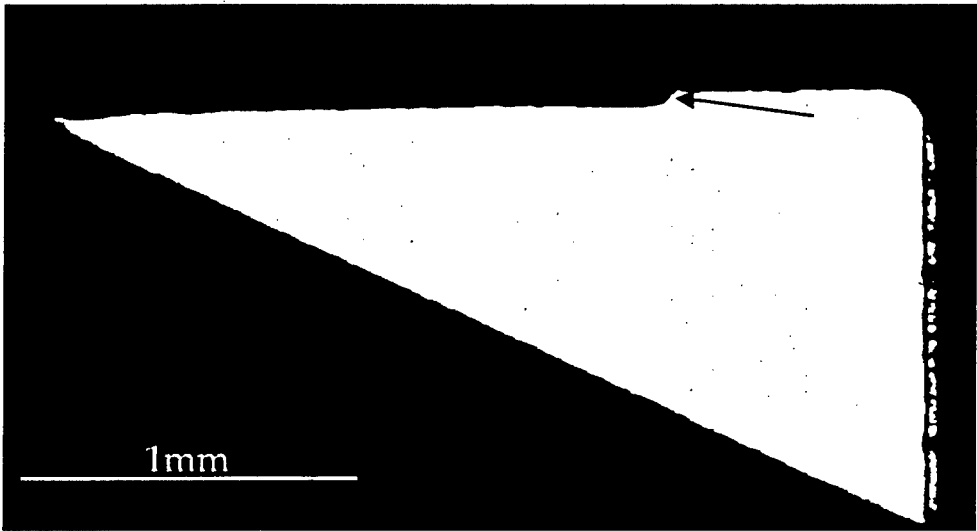
Figure 35 Section through the piece removed from the edge of the port upper aft hole revealed the extent of the step (arrow) caused by the copper alloy bush in the hole.
